TRINITY CHURCH DAM

NDI ID NO. MD-37

PHASE I INSPECTION REPORT

NATIONAL DAM INSPECTION PROGRAM

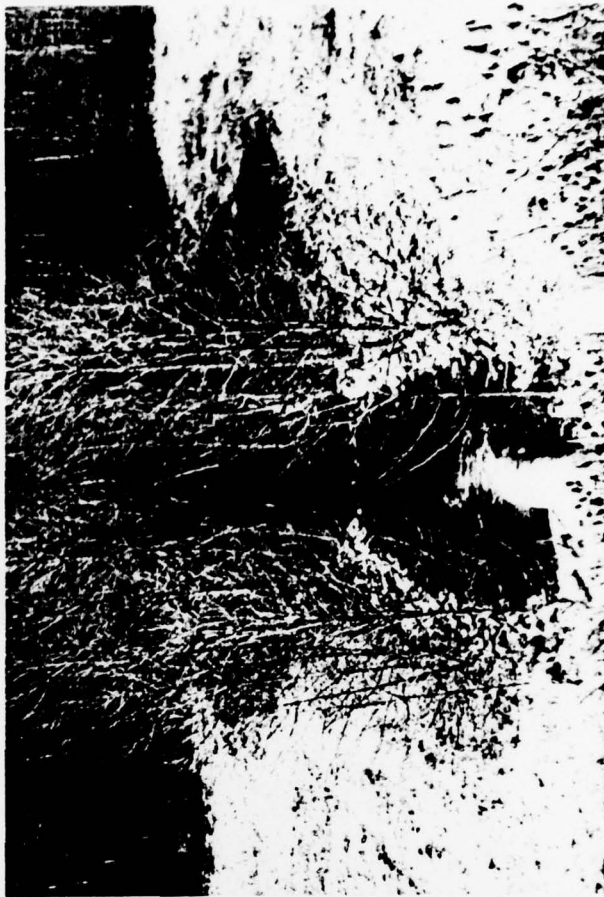
PHOTOGRAPH 5

Seepage drain outlet pipes were found to be partially submerged by plunge pool tailwater. If the outlet channel is obstructed, the water level in the plunge pool could rise, completely submerging these drain outlets. This condition could reduce the efficiency of the seepage drain and make inspection difficult. The outlet channel should be periodically inspected for flow obstructions.

- 3) Seepage. No springs or seeps were observed emanating from the downstream toe area of the dam. The two 8 in. dia. seepage drain outlets are partially submerged by plunge pool tailwater but appear to be flowing (est. 0.5 gpm ea.) and transporting a brown iron precipitate (see Photograph 5). These pipes are partially rusted.

- 1) Remove trees and brush from embankment slopes. Seed and mulch where necessary.
- 2) Repair access road to the dam.
- 3) Repair reservoir drain gate valve.
- 4) Periodically inspect outlet channel. Remove debris and flow obstructions.
- 5) Develop a more active maintenance and inspection program at the dam facility. Program should include frequent inspection of the gate valve, mowing of spillway channel, removal of trees from embankment slopes and filling animal burrows.
- 6) Periodically observe wet zones identified in Section 3.1-b(4) for evidence of seepage emanating from the embankment or change in condition.
- 7) Periodically inspect the seepage drain outlet pipes for corrosive damage. Replace or reline if necessary.
- 8) Develop a flood surveillance and warning plan.
